Transportation Safety Board
of Canada

MARINE INVESTIGATION REPORT
M06W0052

STRIKING AND SUBSEQUENT SINKING

PASSENGER AND VEHICLE FERRY *QUEEN OF THE NORTH*
GIL ISLAND, WRIGHT SOUND, BRITISH COLUMBIA
22 MARCH 2006

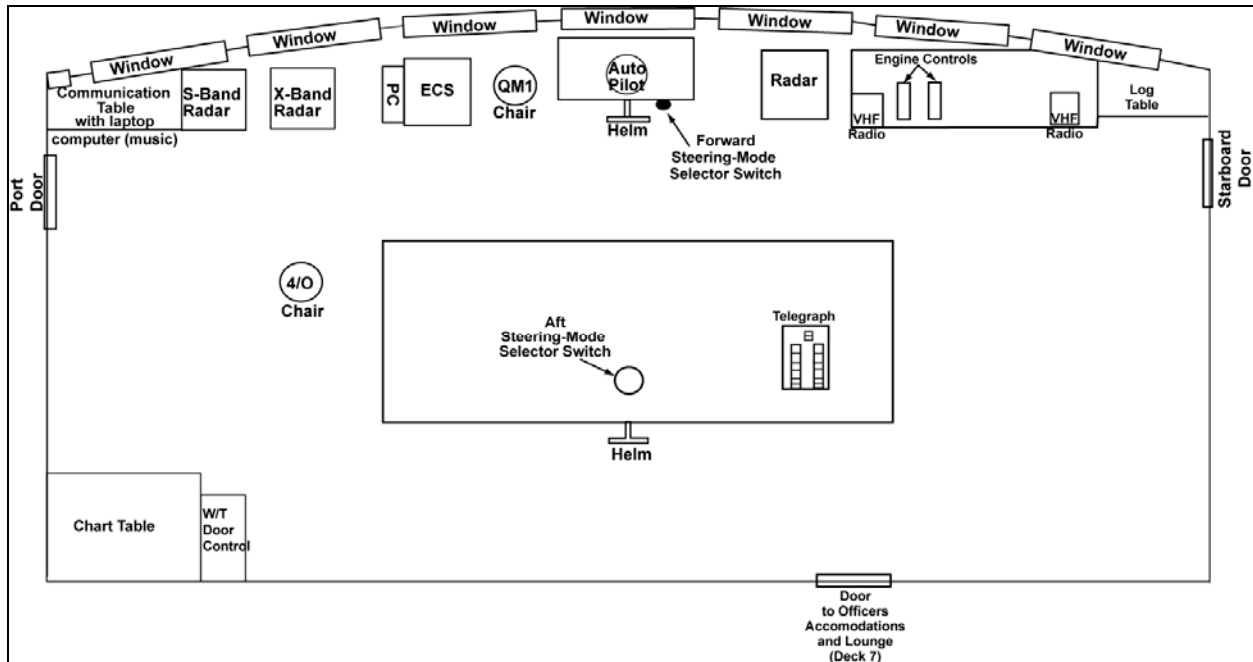
Figure 2. Layout of the bridge (not to scale)

Visibility forward of the beam was not significantly hindered by the design of the bridge or the layout of its equipment (see Figure 2).

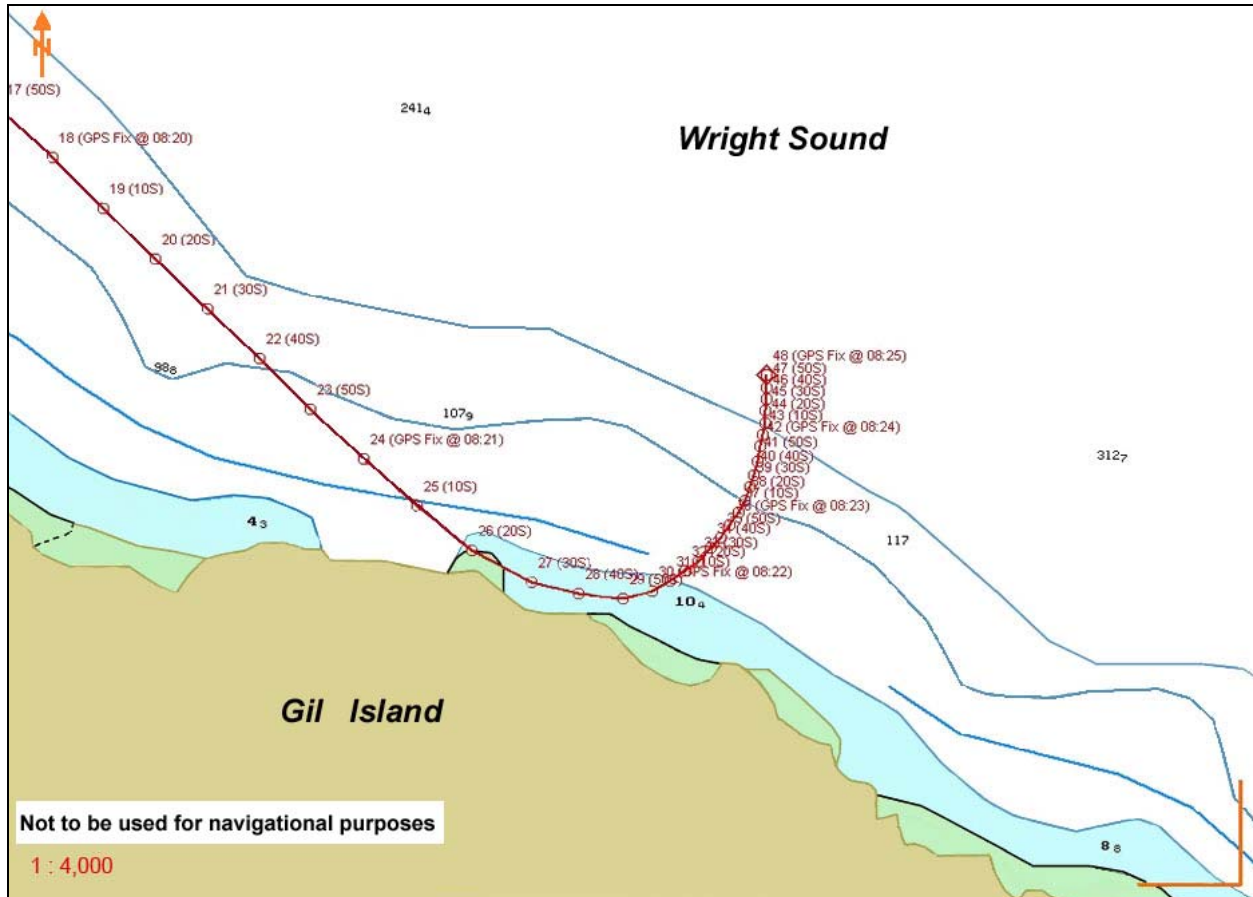
Figure 4. Course as it would have appeared on a vector chart

The above graphic shows the track of the *Queen of the North* as it would have appeared on a vector chart, which, while not available at the time of the accident, clearly shows the vessel’s course both across Wright Sound before and after the striking. The fixes in the electronic chart system data log were updated every minute for the following: date, time, latitude, longitude, heading, course over ground, and speed over ground. Ten-second positions of latitude and longitude depict the vessel’s track moments after the striking.
